Manhole Inspection Summary

Manhole # S130__019MH

Location Address: **2955 Fredrick AV**

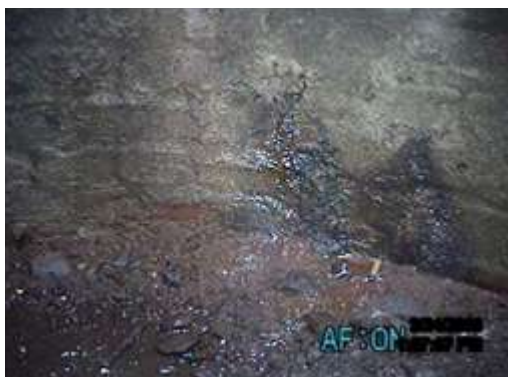
Defect 4

Infiltration: ☐ None ☐ Joint ☐ Cracks ☐ Mortar ☐ Roots ☒ **Wall**

active infiltration in barrel wall

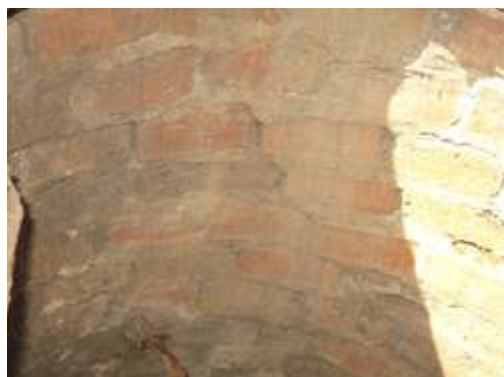
Defect 3

Condition: ☐ Sound ☒ **Cracked** ☐ Root Intrusion ☐ Loose Brick ☐ Deteriorated

chimney cracks bricks/ missing mortar

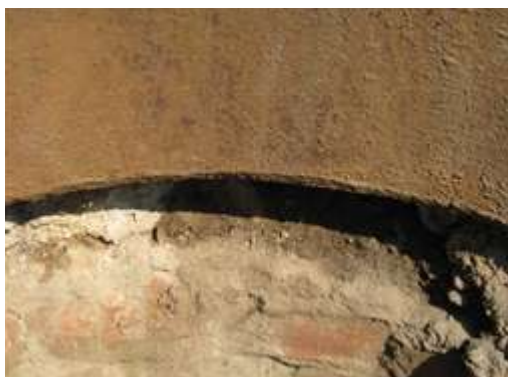
Defect 2

Infiltration: ☐ None ☒ **Joint** ☐ Cracks ☐ Mortar ☐ Roots ☐ Wall

chimney frame joint, signs infiltration at chimney

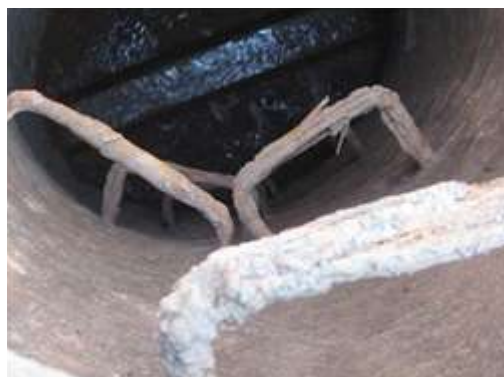
Defect 1

Steps Count: **7** Missing: **0** ☒ **Corroded**

steps corroded

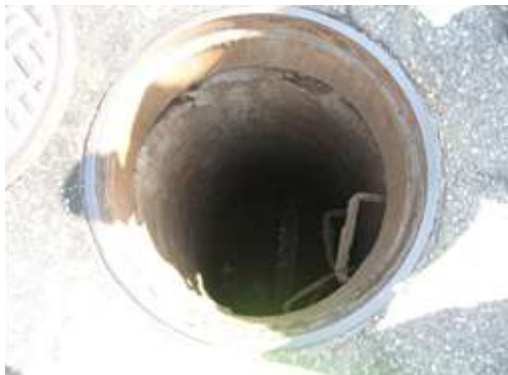
Defect 5

Frame Offset: **2** (in.) Condition: ☐ Sound ☐ Cracked ☐ Leaks

frame offset

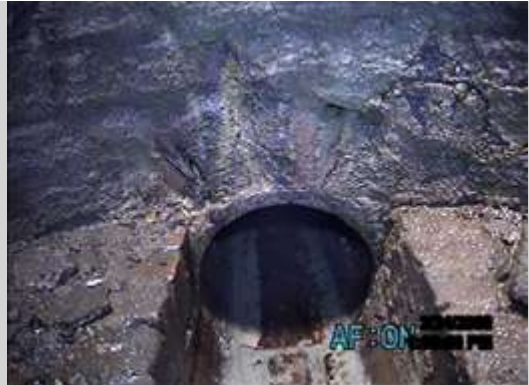
12 O'Clock Outflow

Pipe Height: **8.4** (in.) Rod and Bar (Angled)
Pipe Material: **Clay** ☐ Pipe Lined
Invert Depth: **11.14** (ft.) Flow Characteristics: **Slow**
Deposits: ☒ None ☐ Mud ☐ Sludge ☐ Debris ☐ Grease
Silt Depth: **0** (in.) Deposits Extent:
Infiltration: **Evidence** Pipe Seal Cond: **Unknown**

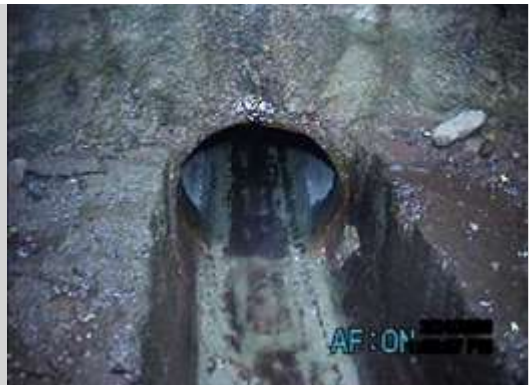
6 O'Clock Inflow

Pipe Height: **8.4** (in.) Rod and Bar (Angled)
Pipe Material: **Clay** ☐ Pipe Lined
Invert Depth: **11.24** (ft.) Flow Characteristics: **Slow**
Deposits: ☒ None ☐ Mud ☐ Sludge ☐ Debris ☐ Grease
Silt Depth: **0** (in.) Deposits Extent:
Infiltration: **Evidence** Pipe Seal Cond: **Unknown**
